**Flood Control Project Maintenance
Levee Inspections**

Fall 2019 Levee Maintenance Deficiency Summary Report

**Flood Control Project Maintenance
Levee Inspections****LMA District Cover Sheet****Fall 2019 Levee Inspection Results****Sacramento River West Side Levee District**

Sacramento River West Side Levee District

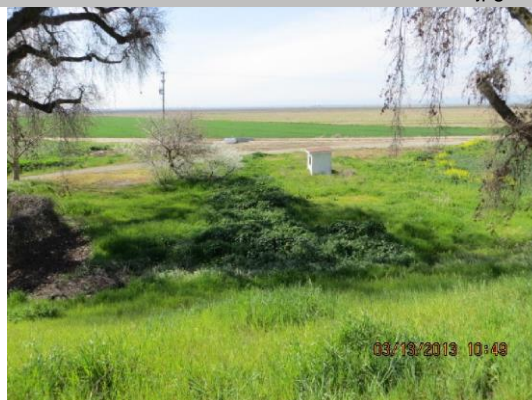
Photo 2 of 2 : UCIP_FA_2019_55861_27170.jpg

Comment Code						
Inspector Comment						
DS_ID:20333						
FS_ID:55861						
EP_NO: 9354						
Repair Type: Non-Urgent						
Crossing Status: Not Found						
UCIP Comments: 09/30/2019 Crossing not found (O.Yakimov - DWR UCIP)						
FIELD_STRUCT_DESC: *ABANDONED* 2 of 3: 48-inch concrete encased steel irrigation pipe through the levee, 29 feet below the crown. Slide gate on the waterside (WS) end. Grouted in place. No above ground appurtenances remain. (Permit No. 9354, 1974 - Reclamation District No. 108). [Additional Reference(s): DWR Levee Log, 2006. USACE Sacramento O&M Manual 130, May 1960 (HLM 14.53)].						
FS Date: 9/30/2019 2:49:03 PM

Location of abandoned pumping plant between large trees.

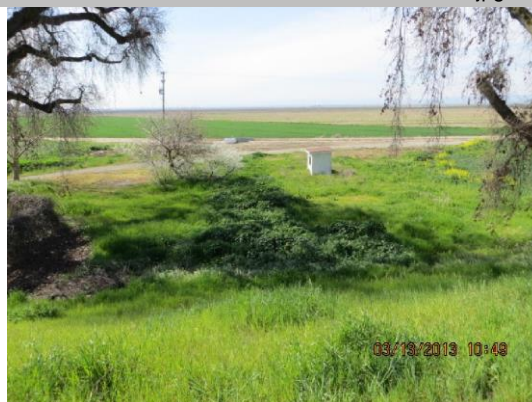
Photo 2 of 2 : UCIP_FA_2019_55862_27172.jpg

LM Start	14.36	Rating **	M	Issue No.	1583	
LM End	14.36	Issue Type +	En	Location *		
Category	Supplemental			GPS Latitude/Longitude		
				Start	End	
Item	DRAFT DWR UCIP Field Study			38.908042 °	38.908042 °	
				-121.811771 °	-121.811771 °	
DWR ID	20236					
Comment Code						
Inspector Comment						
DS_ID:20236 FS_ID:55862 EP_NO: 2887 Repair Type: Non-Urgent Crossing Status: Not Found UCIP Comments: 09/30/2019 Crossing not found (O.Yakimov - DWR UCIP) FIELD_STRUCT_DESC: *ABANDONED* 16-inch steel irrigation pipe through the levee, 2.7 feet below the crown. Vertical pump on the waterside (WS) end. Siphon breaker on the landside (LS) shoulder. (Permit No. 2887, 1958 - Reclamation District No. 108). Grouted in place. No above-ground appurtenances remain. [Additional Reference(s): DWR Levee Log, 2006]. FS Date: 9/30/2019 2:49:21 PM

Location of abandoned pumping plant LS.

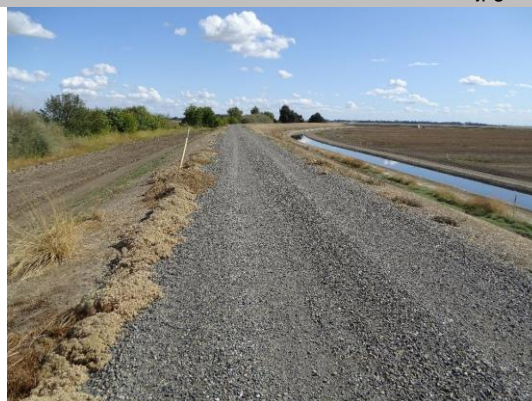
Photo 1 of 3 : UCIP_FA_2019_55882_83117.jpg

LM Start	16.22	Rating **	M	Issue No.	1586
LM End	16.22	Issue Type +	En	Location *	
Category	Supplemental			GPS Latitude/Longitude	
				Start	End
Item	DRAFT DWR UCIP Field Study			38.923407 °	38.923407 °
				-121.834588 °	-121.834588 °
DWR ID	20432				
Comment Code					
Inspector Comment					
DS_ID:20432 FS_ID:55882 EP_NO: N/A Repair Type: Non-Urgent Crossing Status: Found UCIP Comments: 09/30/2019 Permit is not available for this crossing. (O.Yakimov - DWR UCIP)03/13/2013 Need to determine if this is a permitted crossing as it was not previously noted. Need to determine size and depth below the crown. FIELD_STRUCT_DESC: Gas line of an unknown material and diameter through the levee, at an unknown depth. Marker on waterside (WS) shoulder. FS Date: 9/30/2019 3:40:38 PM

View of levee crown at the crossing

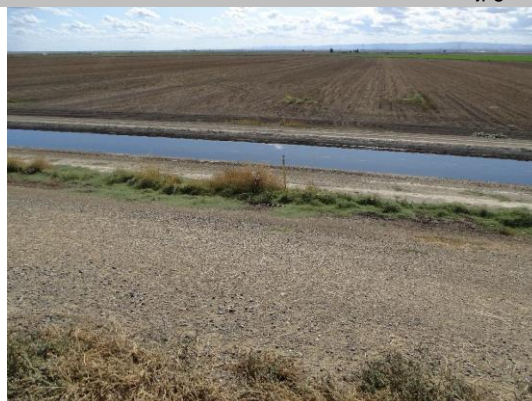
Photo 3 of 3 : UCIP_FA_2019_55882_83119.jpg

LM Start	16.22	Rating **	M	Issue No.	1586 (cont)	
LM End	16.22	Issue Type +	En	Location *		
Category	Supplemental			GPS Latitude/Longitude		
				Start	End	
Item	DRAFT DWR UCIP Field Study			38.923407°	38.923407°	
				-121.834588°	-121.834588°	
DWR ID	20432					
Comment Code						
Inspector Comment						
DS_ID:20432 FS_ID:55882 EP_NO: N/A Repair Type: Non-Urgent Crossing Status: Found UCIP Comments: 09/30/2019 Permit is not available for this crossing. (O.Yakimov - DWR UCIP)03/13/2013 Need to determine if this is a permitted crossing as it was not previously noted. Need to determine size and depth below the crown. FIELD_STRUCT_DESC: Gas line of an unknown material and diameter through the levee, at an unknown depth. Marker on waterside (WS) shoulder. FS Date: 9/30/2019 3:40:38 PM

Gas line marker on LS. Two markers installed on both sides of irrigation ditch

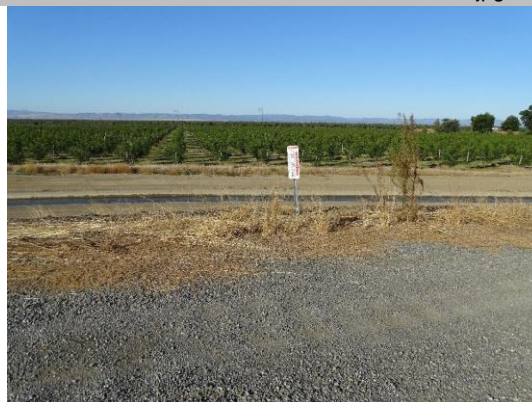
Photo 1 of 2 : UCIP_FA_2019_55890_83135.jpg

LM Start	17.94	Rating **	M	Issue No.	1587	
LM End	17.94	Issue Type +	En	Location *		
Category	Supplemental			GPS Latitude/Longitude		
				Start		End
Item	DRAFT DWR UCIP Field Study			38.942979 °		38.942979 °
				-121.837030 °		-121.837030 °
DWR ID	22957					
Comment Code						
Inspector Comment						
DS_ID:22957 FS_ID:55890 EP_NO: 18026 Repair Type: Non-Urgent Crossing Status: Found UCIP Comments: 10/01/2019 Warning sign of buried 12kV electrical line installed on LS shoulder. No as-built drawing that shows alignment found. (O.Yakimov - DWR UCIP)03/13/2013 Conduit needs to be located and signs installed where it crosses the levee crown. FIELD_STRUCT_DESC: Electrical conduit of an unknown material and diameter through the levee, at an unknown depth. Signage on the landside (LS) shoulder. (Permit No. 18026, 2006 - Reclamation District No. 108). FS Date: 10/1/2019 7:50:52 AM

Warning sign on LS shoulder

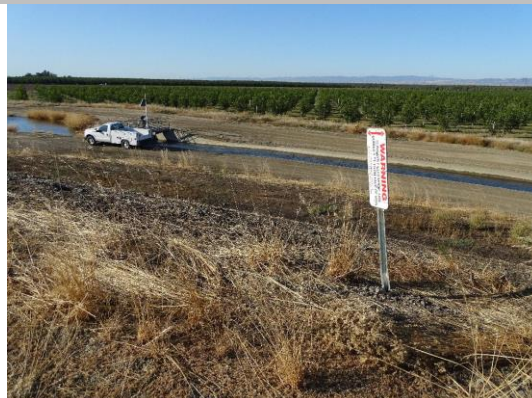
Photo 2 of 2 : UCIP_FA_2019_55890_83136.jpg

Item	DRAFT DWR UCIP Field Study			38.942979 °	38.942979 °	
				-121.837030 °	-121.837030 °	
DWR ID	22957					
Comment Code						
Inspector Comment						
DS_ID:22957						
FS_ID:55890						
EP_NO: 18026						
Repair Type: Non-Urgent						
Crossing Status: Found						
UCIP Comments: 10/01/2019 Warning sign of buried 12kV electrical line installed on LS shoulder. No as-built drawing that shows alignment found. (O.Yakimov - DWR UCIP)03/13/2013 Conduit needs to be located and signs installed where it crosses the levee crown.						
FIELD_STRUCT_DESC: Electrical conduit of an unknown material and diameter through the levee, at an unknown depth. Signage on the landside (LS) shoulder. (Permit No. 18026, 2006 - Reclamation District No. 108).						
FS Date: 10/1/2019 7:50:52 AM

Warning sign on LS shoulder

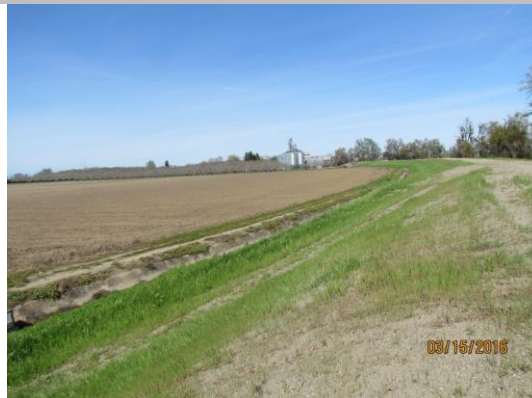
Photo 1 of 1 : FA_2019_NA0016_435_15_20190829_00003.jpg

LM Start	18.20	Rating **	M	Issue No.	15
LM End	18.46	Issue Type +	En	Location *	LS
Category	Earthen Levee			GPS Latitude/Longitude	
				Start	End
Item	Encroachments			38.946674 °	38.950263 °
				-121.837528 °	-121.837768 °
DWR ID	DWR_NA0016_01_s_2012_15				
Comment Code					
DT : Ditch					
Inspector Comment					
A concrete lined ditch runs along the toe of the levee.

View of the ditch on the landward side of the levee looking upstream.
Spring 2016.

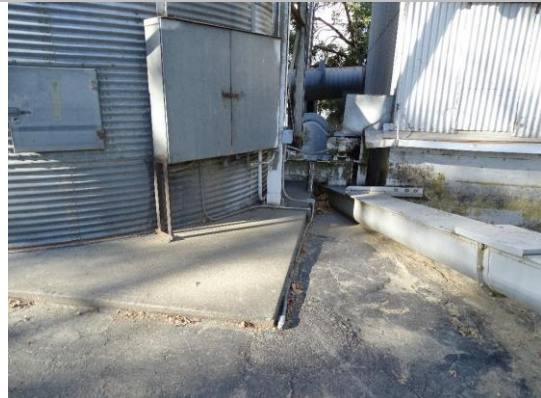
Photo 1 of 3 : UCIP_FA_2019_55894_83143.jpg

Comment Code						
Inspector Comment						
DS_ID:20240 FS_ID:55894 EP_NO: 4938B Repair Type: Non-Urgent Crossing Status: Found UCIP Comments: 10/01/2019 Crossing not in use. Property manager confirmed that a pump at riverbank has been removed and electrical puply was disconnected. Water to WS is supplied through a hose above levee crown. (O.Yakimov - DWR UCIP) FIELD_STRUCT_DESC: 1-inch galvanized iron electrical conduit through the levee, 1 foot below the crown. Conduit supplies power to 8-inch pump and pipe on the waterside (WS) slope. Pump supplies water to sprinklers on the WS slope. (Permit No. 4938-A, 1974 - Owner Unknown). FS Date: 10/1/2019 8:17:23 AM

Electrical conduit at edge of concrete base of grainery

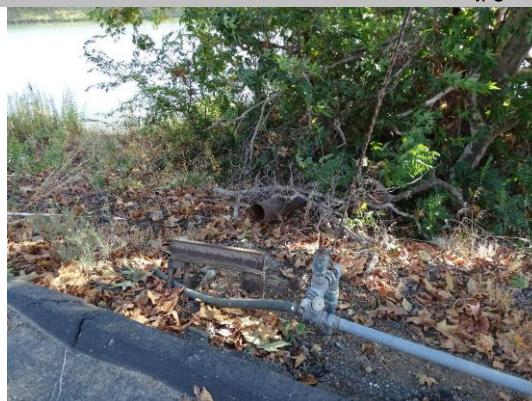
Photo 3 of 3 : UCIP_FA_2019_55894_83145.jpg

Item	DRAFT DWR UCIP Field Study			38.951135 °	38.951135 °	
				-121.838113 °	-121.838113 °	
DWR ID	20240					
Comment Code						
Inspector Comment						
DS_ID:20240						
FS_ID:55894						
EP_NO: 4938B						
Repair Type: Non-Urgent						
Crossing Status: Found						
UCIP Comments: 10/01/2019 Crossing not in use. Property manager confirmed that a pump at riverbank has been removed and electrical puply was disconnected. Water to WS is supplied through a hose above levee crown. (O.Yakimov - DWR UCIP)						
FIELD_STRUCT_DESC: 1-inch galvanized iron electrical conduit through the levee, 1 foot below the crown. Conduit supplies power to 8-inch pump and pipe on the waterside (WS) slope. Pump supplies water to sprinklers on the WS slope. (Permit No. 4938-A, 1974 - Owner Unknown).						
FS Date: 10/1/2019 8:17:23 AM

Cutoff 8-inch pipe that was used to provide water for sprinklers on WS

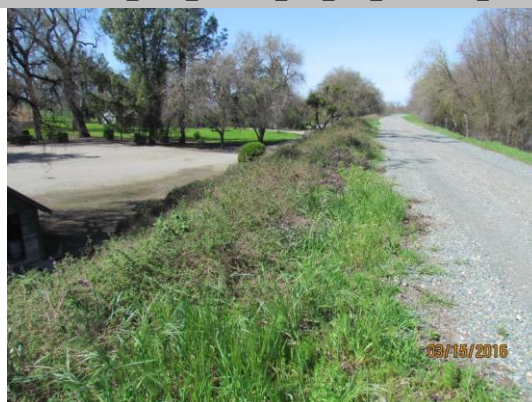
Photo 1 of 2 : FA_2019_NA0016_435_173_20190829_00065.jpg

LM Start	18.66	Rating **	M	Issue No.	173
LM End	18.70	Issue Type +	En	Location *	LS
Category	Earthen Levee			GPS Latitude/Longitude	
				Start	End
Item	Vegetation			38.952765 °	38.953219 °
				-121.839661 °	-121.840199 °
DWR ID	DWR_NA0016_01_s_2019_173				
Comment Code					
V6 : Landscaping					
Inspector Comment					
Permit number 16487. Owner needs to maintain/trim vegetation.

View of the landscaping on the landward side of the levee looking upstream. Spring 2016.

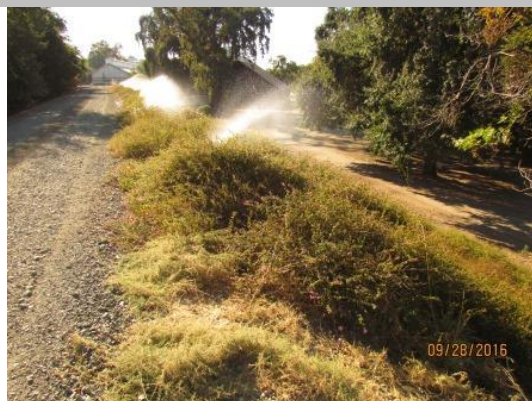
Photo 2 of 2 : FA_2019_NA0016_435_173_20190829_00066.jpg

LM Start	18.66	Rating **	M	Issue No.	173 (cont)	
LM End	18.70	Issue Type +	En	Location *	LS	
Category	Earthen Levee			GPS Latitude/Longitude		
				Start		End
Item	Vegetation			38.952765 °		38.953219 °
				-121.839661 °		-121.840199 °
DWR ID	DWR_NA0016_01_s_2019_173					
Comment Code						
V6 : Landscaping						
Inspector Comment						
Permit number 16487. Owner needs to maintain/trim vegetation.

Irrigated landscaping on landside slope of the levee reaching levee crown. Fall 2016 inspection.

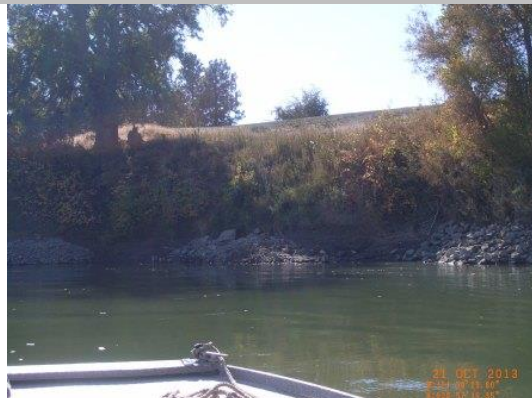
Photo 1 of 1 : FA_2019_NA0016_435_85_20190829_00023.jpg

LM Start	18.76	Rating **	A/W	Issue No.	85
LM End	18.78	Issue Type +	Ma	Location *	WS
Category	Supplemental			GPS Latitude/Longitude	
				Start	End
Item	2017 USACE Erosion Survey			38.954060 °	38.954312 °
				-121.840560 °	-121.840774 °
DWR ID	DWR_NA0016_01_f_2018_85				
Comment Code					
Inspector Comment					
2017 Site ID: SAC 111.0 R					
Status: Eroding					
2017 Field Notes: No observed change.					
Site History: 2009 - Minor erosion, should be repaired under maintenance. 2011 - Some new minor erosion at the toe.

USACE 2013 Photo #1

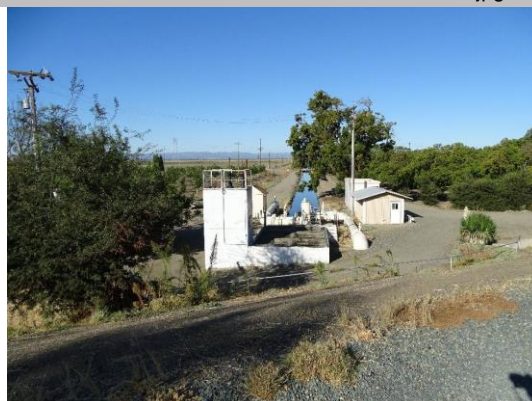
Photo 1 of 3 : UCIP_FA_2019_55898_83151.jpg

LM Start	18.79	Rating **	M	Issue No.	1590
LM End	18.79	Issue Type +	En	Location *	
Category	Supplemental			GPS Latitude/Longitude	
				Start	End
Item	DRAFT DWR UCIP Field Study			38.954200 °	38.954200 °
				-121.841055 °	-121.841055 °
DWR ID	20387				
Comment Code					
Inspector Comment					
DS_ID:20387 FS_ID:55898 EP_NO: 1359 Repair Type: Non-Urgent Crossing Status: Indicator Found UCIP Comments: 10/01/2019 Pipe not visible on WS. Water level in distribution box is too high to see the pipe. (O.Yakimov - DWR UCIP) FIELD_STRUCT_DESC: 3 of 3: 24-inch drainage discharge pipe of an unknown material through the levee, 12.5 feet below the crown. Lift station is a good indicator of the location. (Permit No. 1359, 1948 - Reclamation District No. 108). [Additional Reference(s): USACE Sacramento O&M Manual 130, May 1960 (HLM 19.02)]. FS Date: 10/1/2019 9:09:41 AM

Lift station on LS at levee toe

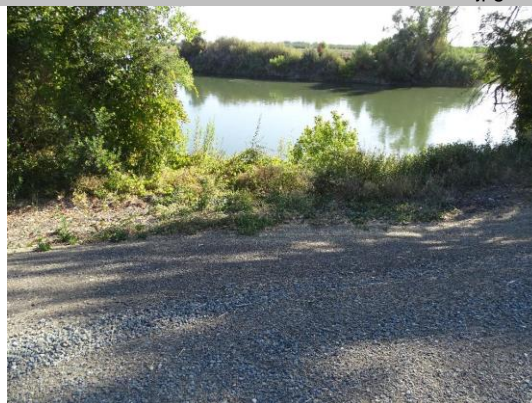
Photo 2 of 3 : UCIP_FA_2019_55898_83152.jpg

View of WS looking from levee crown

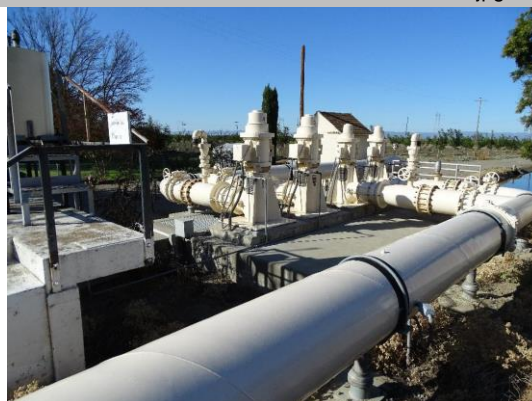
Photo 3 of 3 : UCIP_FA_2019_55898_83153.jpg

LM Start	18.79	Rating **	M	Issue No.	1590 (cont)	
LM End	18.79	Issue Type +	En	Location *		
Category	Supplemental			GPS Latitude/Longitude		
				Start	End	
Item	DRAFT DWR UCIP Field Study			38.954200 °	38.954200 °	
				-121.841055 °	-121.841055 °	
DWR ID	20387					
Comment Code						
Inspector Comment						
DS_ID:20387 FS_ID:55898 EP_NO: 1359 Repair Type: Non-Urgent Crossing Status: Indicator Found UCIP Comments: 10/01/2019 Pipe not visible on WS. Water level in distribution box is too high to see the pipe. (O.Yakimov - DWR UCIP) FIELD_STRUCT_DESC: 3 of 3: 24-inch drainage discharge pipe of an unknown material through the levee, 12.5 feet below the crown. Lift station is a good indicator of the location. (Permit No. 1359, 1948 - Reclamation District No. 108). [Additional Reference(s): USACE Sacramento O&M Manual 130, May 1960 (HLM 19.02)]. FS Date: 10/1/2019 9:09:41 AM

Pumps in irrigation canal on LS

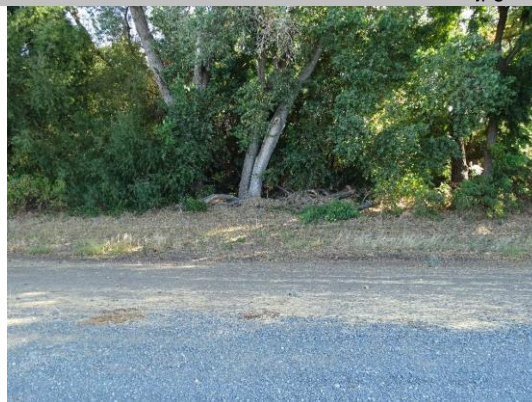
Photo 1 of 2 : UCIP_FA_2019_55897_83149.jpg

Comment Code					
Inspector Comment					
DS_ID:20303 FS_ID:55897 EP_NO: 9325 Repair Type: Non-Urgent Crossing Status: Not Found UCIP Comments: 10/01/2019 Crossing not found. According to the permit pipe is located upstream of the lift station. (O.Yakimov - DWR UCIP) FIELD_STRUCT_DESC: *ABANDONED* 7-inch steel irrigation pipe through the levee, 8 feet below the crown. Gate valve on the waterside (WS) end. Lift station good indicator of location. (Automatic Board Order (ABO) issued as Permit No. 9325, 1974 - Leda B. Miller). [Additional Reference(s): DWR Levee Log, 1980. USACE Sacramento O&M Manual 130, May 1960 (HLM 19.04)]. FS Date: 10/1/2019 8:59:03 AM

View of WS at potential crossing looking from levee crown

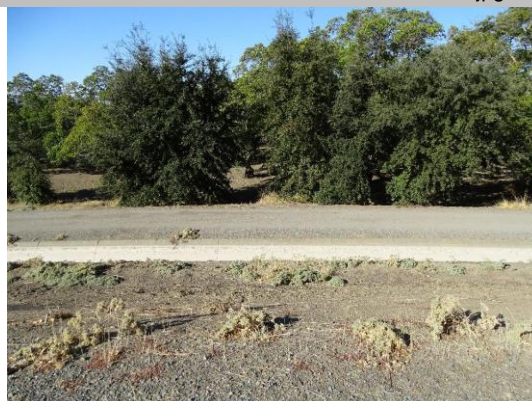
Photo 2 of 2 : UCIP_FA_2019_55897_83150.jpg

Item	DRAFT DWR UCIP Field Study			38.954734 °	38.954734 °	
				-121.841418 °	-121.841418 °	
DWR ID	20303					
Comment Code						
Inspector Comment						
DS_ID:20303						
FS_ID:55897						
EP_NO: 9325						
Repair Type: Non-Urgent						
Crossing Status: Not Found						
UCIP Comments: 10/01/2019 Crossing not found. According to the permit pipe is located upstream of the lift station. (O.Yakimov - DWR UCIP)						
FIELD_STRUCT_DESC: *ABANDONED* 7-inch steel irrigation pipe through the levee, 8 feet below the crown. Gate valve on the waterside (WS) end. Lift station good indicator of location. (Automatic Board Order (ABO) issued as Permit No. 9325, 1974 - Leda B. Miller).						
[Additional Reference(s): DWR Levee Log, 1980. USACE Sacramento O&M Manual 130, May 1960 (HLM 19.04)].						
FS Date: 10/1/2019 8:59:03 AM

View of LS at potential crossing looking from levee crown

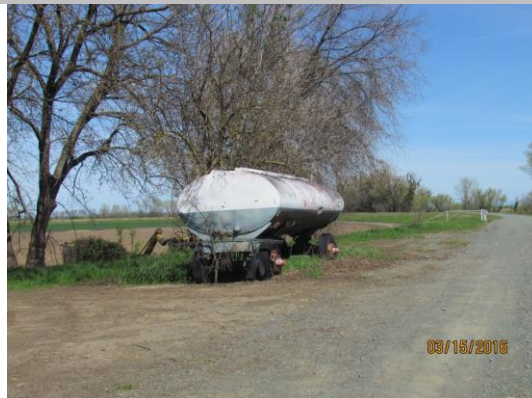
Photo 2 of 2 : FA_2019_NA0016_435_26_20190829_00006.jpg

LM Start	19.12	Rating **	M	Issue No.	26 (cont)	
LM End	19.12	Issue Type +	En	Location *	LS	
Category	Earthen Levee			GPS Latitude/Longitude		
				Start	End	
Item	Encroachments			38.957180 °	38.957180 °	
				-121.837442 °	-121.837442 °	
DWR ID	DWR_NA0016_01_s_2012_26					
Comment Code						
EQ : Equipment						
Inspector Comment						
Beehives and tank are located on the landside slope.

View of the equipment on the crown of the levee looking upstream. Spring 2016.

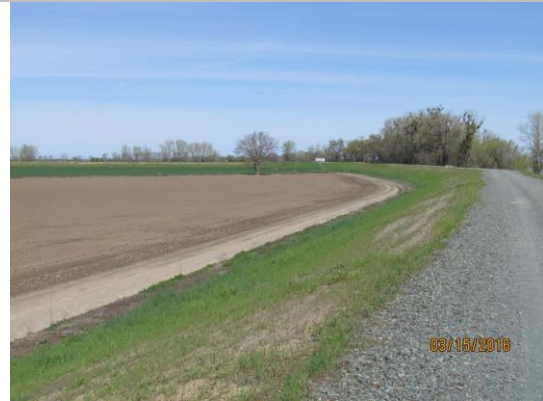
Photo 1 of 2 : FA_2019_NA0016_435_31_20190829_00011.jpg

LM Start	19.15	Rating **	M	Issue No.	31
LM End	19.61	Issue Type +	En	Location *	LS
Category	Earthen Levee			GPS Latitude/Longitude	
				Start	End
Item	Encroachments			38.957405 °	38.962648 °
				-121.836965 °	-121.834368 °
DWR ID	DWR_NA0016_01_s_2012_31				
Comment Code					
DT : Ditch					
Inspector Comment					
Concrete lined ditch up to LM 19.40. Soil ditch continues on until LM 19.61.

View of the ditch on the landward side of the levee looking upstream. Spring 2016.

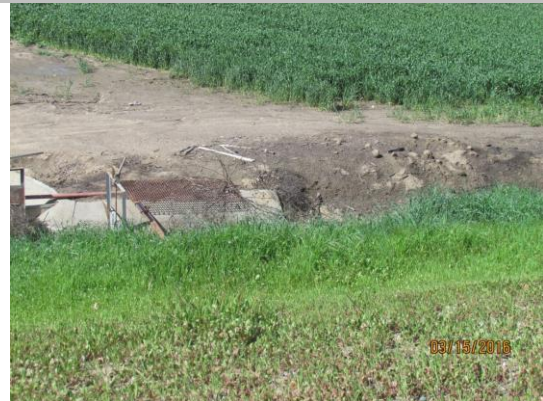
Photo 2 of 2 : FA_2019_NA0016_435_31_20190829_00012.jpg

Concrete lined ditch stops at levee mile 19.40.

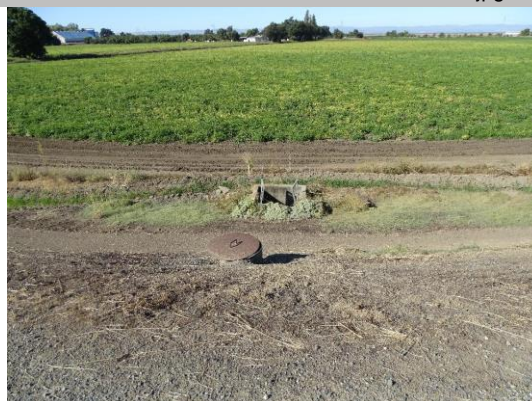
Photo 1 of 3 : UCIP_FA_2019_55904_83158.jpg

Comment Code						
Inspector Comment						
DS_ID:20246 FS_ID:55904 EP_NO: 1507 Repair Type: Non-Urgent Crossing Status: Found UCIP Comments: 10/01/2019 Crossing not in use. Sediment and debris observed inside of the pipe and concrete distribution box on LS. (O.Yakimov - DWR UCIP)03/13/2013 Pipe appears abandoned. Needs to be abandoned properly. FIELD_STRUCT_DESC: 14-inch steel irrigation pipe through the levee, 8.4 feet below the crown. Gate valve on the waterside (WS). Siphon breaker inside a 24-inch corrugated metal riser unit on the landside (LS) slope. Concrete distribution box inside an irrigation ditch on the LS toe. (Permit No. 1507, 1950 - Morgan Miller Jr.). [Additional Reference(s): DWR Levee Log, 2006. USACE Sacramento O&M Manual 130, May 1960 (HLM 19.74)]. FS Date: 10/1/2019 11:27:39 AM

CMP riser on shoulder and concrete distribution box at LS toe

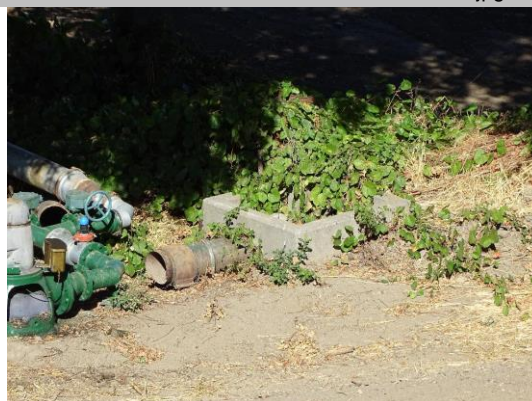
Photo 2 of 3 : UCIP_FA_2019_55905_83164.jpg

LM Start	20.02	Rating **	M	Issue No.	1595 (cont)	
LM End	20.02	Issue Type +	En	Location *		
Category	Supplemental			GPS Latitude/Longitude		
				Start	End	
Item	DRAFT DWR UCIP Field Study			38.968342 °	38.968342 °	
				-121.835613 °	-121.835613 °	
DWR ID	20336					
Comment Code						
Inspector Comment						
DS_ID:20336 FS_ID:55905 EP_NO: N/A Repair Type: Non-Urgent Crossing Status: Not Found UCIP Comments: 10/01/2019 Crossing not found. A well and concrete box on LS are not connected with this crossing. (O.Yakimov - DWR UCIP) FIELD_STRUCT_DESC: 6-inch irrigation pipe of an unknown material through the levee, 5 feet below the crown. Pump on the waterside (WS). [Additional Reference(s): USACE Sacramento O&M Manual 130, May 1960 (HLM 20.25)]. FS Date: 10/1/2019 11:36:17 AM

A well and concrete box

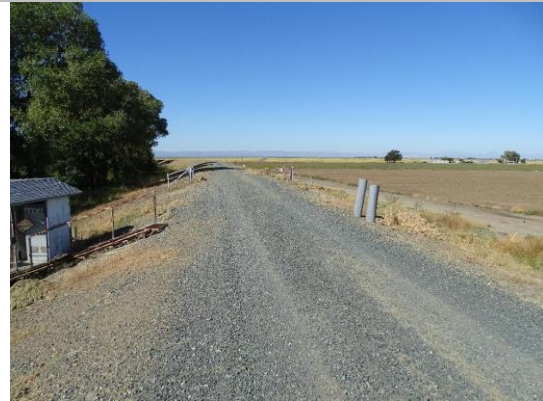
Photo 1 of 3 : UCIP_FA_2019_55909_83174.jpg

Comment Code						
Inspector Comment						
DS_ID:20368 FS_ID:55909 EP_NO: 2407 Repair Type: Non-Urgent Crossing Status: Found UCIP Comments: 10/01/2019 Crossing looks abandoned. Pipe is capped on WS slope. (O.Yakimov - DWR UCIP) FIELD_STRUCT_DESC: 2 of 2: 18-inch steel irrigation pipe through the levee, 4 feet below the crown. Two slant pumps mounted on a steel pipe structure on the waterside (WS) berm. Siphon breakers on the landside (LS) slope inside a steel riser unit. Distribution box on the LS. Flow meter inside a 2-foot corrugated metal riser unit at the WS toe. (Permit No. 2407, 1956 - Reclamation District No. 108). [Additional Reference(s): DWR Levee Log, 2006. USACE Sacramento O&M Manual 130, May 1960 (HLM 22.36)]. FS Date: 10/1/2019 1:33:20 PM

View of levee crown at the crossing

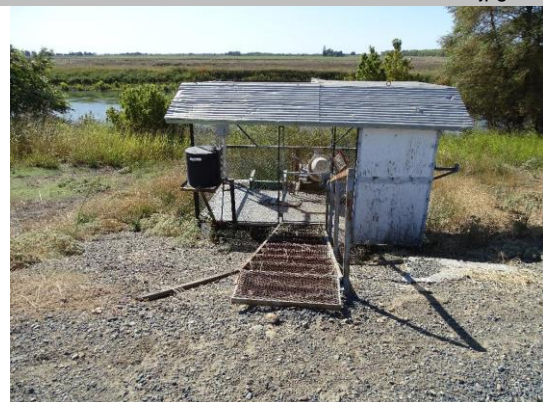
Photo 2 of 3 : UCIP_FA_2019_55909_83178.jpg

View of WS looking from levee crown

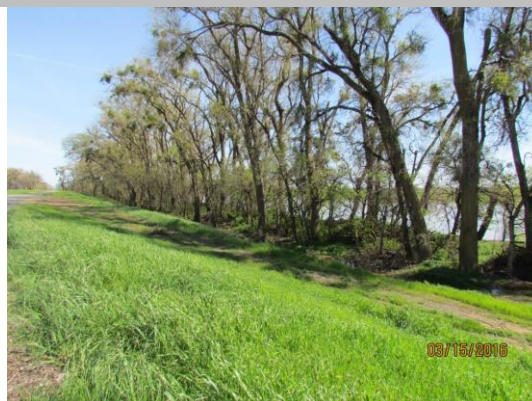
Photo 2 of 2 : FA_2019_NA0016_435_30_20190829_00010.jpg

LM Start	22.12	Rating **	A/W	Issue No.	30 (cont)	
LM End	22.42	Issue Type +	Ob	Location *	WS	
Category	Earthen Levee			GPS Latitude/Longitude		
				Start		End
Item	Vegetation			38.989528 °	38.989722 °	
				-121.816020 °	-121.810488 °	
DWR ID	DWR_NA0016_01_f_2018_30					
Comment Code						
V8 : Environmental Requirements.						
Inspector Comment

View of the revegetation on the waterward berm of the levee looking upstream. Spring 2016.

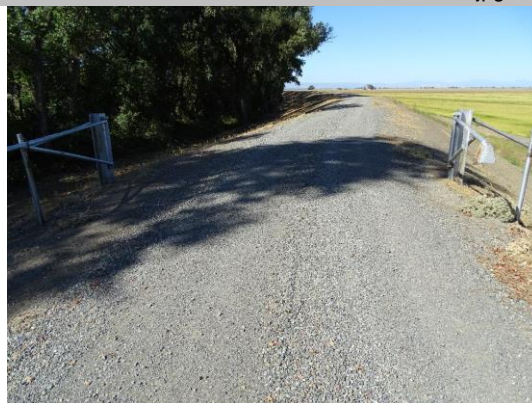
Photo 1 of 3 : UCIP_FA_2019_55910_83181.jpg

LM Start	22.71	Rating **	M	Issue No.	1598	
LM End	22.71	Issue Type +	En	Location *		
Category	Supplemental			GPS Latitude/Longitude		
				Start		End
Item	DRAFT DWR UCIP Field Study			38.989862 °		38.989862 °
				-121.805243 °		-121.805243 °
DWR ID	20248					
Comment Code						
Inspector Comment						
DS_ID:20248						
FS_ID:55910						
EP_NO: 9354						
Repair Type: Non-Urgent						
Crossing Status: Found						
UCIP Comments: 10/01/2019 Crossing looks abandoned. (O.Yakimov - DWR UCIP)03/13/2013 Pipe needs to be verified as having been properly abandoned.						
FIELD_STRUCT_DESC: 24-inch irrigation pipe of an unknown material through the levee, 19.5 feet below the crown. Abandoned concrete pump house on the waterside (WS) toe. [Additional Reference(s): USACE Sacramento O&M Manual 130, May 1960 (HLM 22.99)].						
FS Date: 10/1/2019 1:41:18 PM

View of levee crown at the crossing

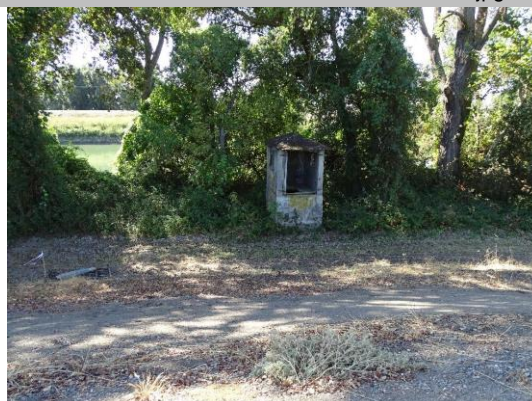
Photo 2 of 3 : UCIP_FA_2019_55910_83182.jpg

LM Start	22.71	Rating **	M	Issue No.	1598 (cont)
LM End	22.71	Issue Type +	En	Location *	
Category	Supplemental			GPS Latitude/Longitude	
				Start	End
Item	DRAFT DWR UCIP Field Study			38.989862 °	38.989862 °
				-121.805243 °	-121.805243 °
DWR ID	20248				
Comment Code					
Inspector Comment					
DS_ID:20248 FS_ID:55910 EP_NO: 9354 Repair Type: Non-Urgent Crossing Status: Found UCIP Comments: 10/01/2019 Crossing looks abandoned. (O.Yakimov - DWR UCIP)03/13/2013 Pipe needs to be verified as having been properly abandoned. FIELD_STRUCT_DESC: 24-inch irrigation pipe of an unknown material through the levee, 19.5 feet below the crown. Abandoned concrete pump house on the waterside (WS) toe. [Additional Reference(s): USACE Sacramento O&M Manual 130, May 1960 (HLM 22.99)]. FS Date: 10/1/2019 1:41:18 PM

Concrete pumphouse on WS berm

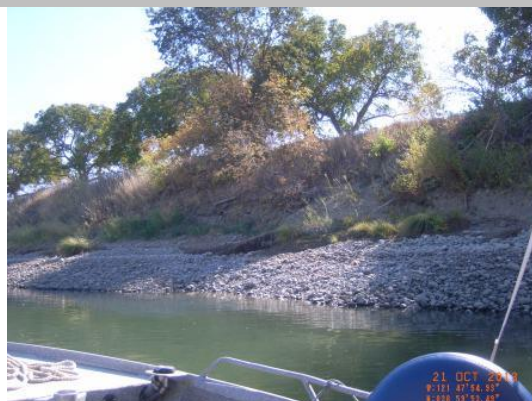
Photo 1 of 1 : FA_2019_NA0016_435_86_20190829_00024.jpg

LM Start	23.55	Rating **	A/W	Issue No.	86
LM End	23.65	Issue Type +	Ma	Location *	WS
Category	Supplemental			GPS Latitude/Longitude	
				Start	End
Item	2017 USACE Erosion Survey			38.997696 °	38.998336 °
				-121.797584 °	-121.799298 °
DWR ID	DWR_NA0016_01_f_2018_86				
Comment Code					
Inspector Comment					
2017 Site ID: SAC 115.9 R					
Status: Eroding					
2017 Field Notes: No observed change.					
Site History: 2008 - Slippage of cobbles off hard underlying toe material. 2011 - Minor slumping site. 2012 - Failing cobble site, site extended upstream. 2016 - New erosion pockets.

USACE 2013 Photo #1

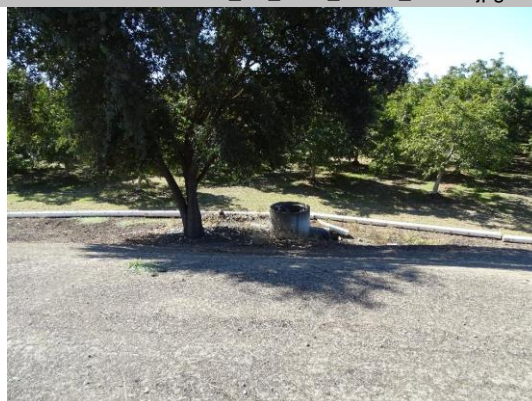
Photo 1 of 3 : UCIP_FA_2019_55911_83183.jpg

Comment Code					
Inspector Comment					
DS_ID:20249 FS_ID:55911 EP_NO: 9374 Repair Type: Non-Urgent Crossing Status: Found UCIP Comments: 10/01/2019 Crossing looks abandoned. On WS slope in CMP riser slide gate stem is bent putting slide gate in non-operational condition. Slide gate is currently in closed position. (O.Yakimov - DWR UCIP)03/14/2013 Appears abandoned. Pipe should be properly abandoned. FIELD_STRUCT_DESC: 1 of 4: 36-inch corrugated metal irrigation pipe through the levee, 20 feet below the crown. One corrugated metal cutoff wall installed by the United States Army Corp of Engineers, 1955. Slide gate inside a 36-inch corrugated metal riser unit on the waterside (WS) slope. Pump on the WS bank. Concrete standpipe on the landside (LS) toe. (Automatic Board Order (ABO) issued as Permit No. 9374, 1974 - Richard H. Moore). [Additional Reference(s): USACE Sacramento O&M Manual 130, May 1960 (HLM 24.03)]. FS Date: 10/1/2019 1:45:53 PM

Concrete standpipe on LS toe

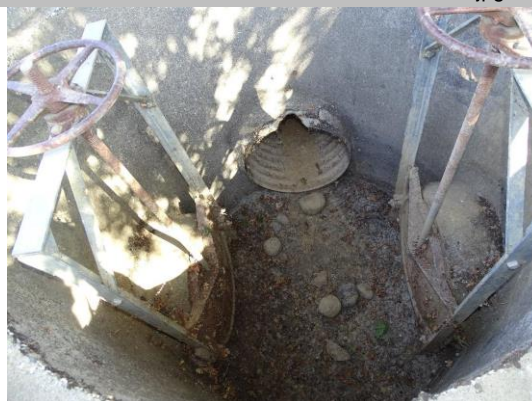
Photo 2 of 3 : UCIP_FA_2019_55911_83184.jpg

Item	DRAFT DWR UCIP Field Study			38.998247°	38.998247°	
				-121.800236°	-121.800236°	
DWR ID	20249					
Comment Code						
Inspector Comment						
DS_ID:20249 FS_ID:55911 EP_NO: 9374 Repair Type: Non-Urgent Crossing Status: Found UCIP Comments: 10/01/2019 Crossing looks abandoned. On WS slope in CMP riser slide gate stem is bent putting slide gate in non-operational condition. Slide gate is currently in closed position. (O.Yakimov - DWR UCIP)03/14/2013 Appears abandoned. Pipe should be properly abandoned. FIELD_STRUCT_DESC: 1 of 4: 36-inch corrugated metal irrigation pipe through the levee, 20 feet below the crown. One corrugated metal cutoff wall installed by the United States Army Corp of Engineers, 1955. Slide gate inside a 36-inch corrugated metal riser unit on the waterside (WS) slope. Pump on the WS bank. Concrete standpipe on the landside (LS) toe. (Automatic Board Order (ABO) issued as Permit No. 9374, 1974 - Richard H. Moore). [Additional Reference(s): USACE Sacramento O&M Manual 130, May 1960 (HLM 24.03)]. FS Date: 10/1/2019 1:45:53 PM

View inside of concrete standpipe on LS toe

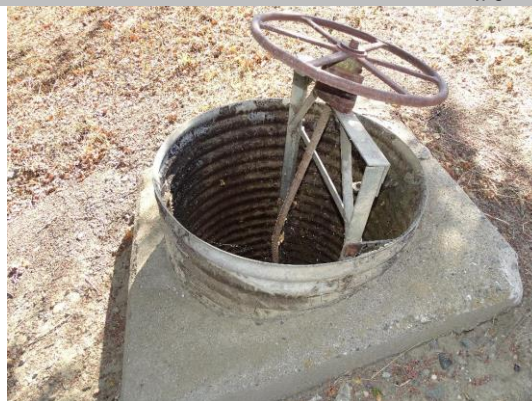
Photo 3 of 3 : UCIP_FA_2019_55911_83186.jpg

LM Start	23.70	Rating **	M	Issue No.	1599 (cont)
LM End	23.70	Issue Type +	En	Location *

Bent stem of slide gate in CMP riser on WS slope

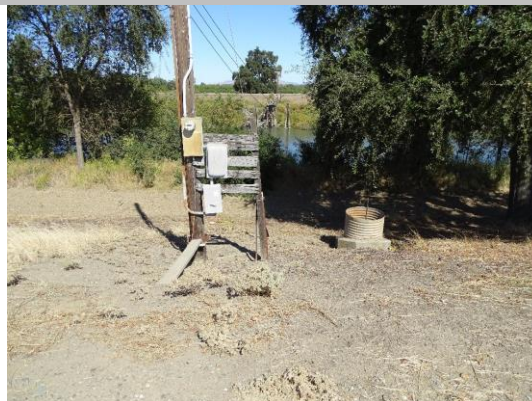
Photo 1 of 3 : UCIP_FA_2019_55914_83194.jpg

Comment Code						
Inspector Comment						
DS_ID:20251 FS_ID:55914 EP_NO: 9328 Repair Type: Non-Urgent Crossing Status: Found UCIP Comments: 10/01/2019 Observed pipe running. No leaks detected. (O.Yakimov - DWR UCIP)03/14/2013 Appears abandoned. Needs to be abandoned properly. FIELD_STRUCT_DESC: 24-inch corrugated metal irrigation pipe through the levee, 20 feet below the crown. Slide gate inside a 36-inch corrugated metal riser unit on the waterside (WS) slope. 7-foot by 9-foot distribution box at the toe of the landside (LS) slope. (Automatic Board Order (ABO) issued as Permit No. 9328, 1974 - Wayne A. Hine). [Additional Reference(s): DWR Levee Log, 2006. USACE Sacramento O&M Manual 130, May 1960 (HLM 25.02)]. FS Date: 10/1/2019 2:28:31 PM

View of WS looking from levee crown

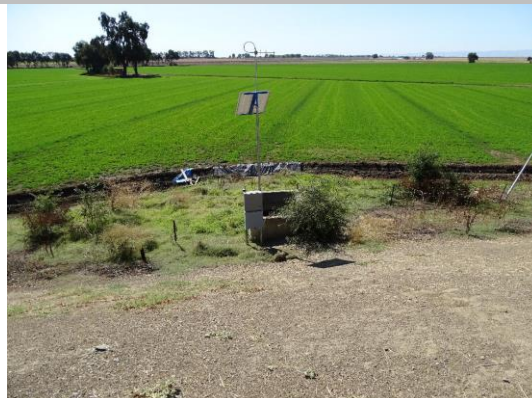
Photo 2 of 3 : UCIP_FA_2019_55914_83195.jpg

LM Start	24.73	Rating **	M	Issue No.	1601 (cont)
LM End	24.73	Issue Type +	En	Location *

View of LS looking from levee crown

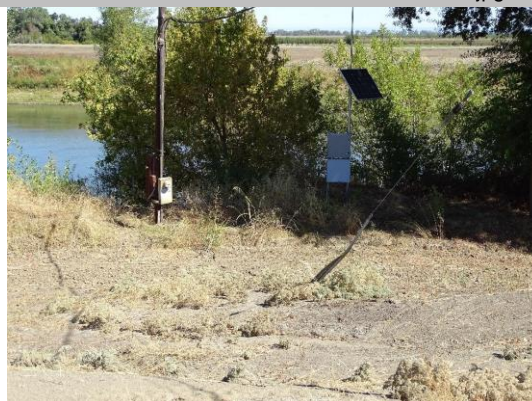
Photo 1 of 3 : UCIP_FA_2019_55915_83200.jpg

Comment Code						
Inspector Comment						
DS_ID:20339 FS_ID:55915 EP_NO: 9330 Repair Type: Non-Urgent Crossing Status: Found UCIP Comments: 10/01/2019 No issues recorded during inspection. (O.Yakimov - DWR UCIP)09/23/2016 - pump in operation during field visit. Gate valve was located on the WS near the powerpole. Visible pipe is a 6 inch on both the LS and WS. 10 inch may be buried within the levee prism, if present. (T. Hatch/UCIP) 09/01/2016 sink hole on WS berm appears to have been repaired. WS pump platform appears unchanged from previous inspection. pipe discharges into canal on LS toe and appears to be encased in concrete under tree on LS toe. (T. Hatch/UCIP) 03/14/2013 Possible sink hole over pipe alignment on WS berm at rivers edge. general condition of pipe and appurtances in disrepair. (W. Wylie/UCIP) FIELD_STRUCT_DESC: 10-inch steel irrigation pipe through the levee, 12.3 feet below the crown. 6-inch pipe discharges into a 10-inch pipe on the waterside (WS). Portable pump and gate valve on the WS. Power pole and anchor on the WS shoulder and toe. (Automatic Board Order (ABO) issued as Permit No. 9330, 1974 - Paul Locvich). [Additional Reference(s): DWR Levee Log, 2006. USACE Sacramento O&M Manual 130, May 1960 (HLM 25.31)]. FS Date: 10/1/2019 2:40:26 PM

View of WS looking from levee crown

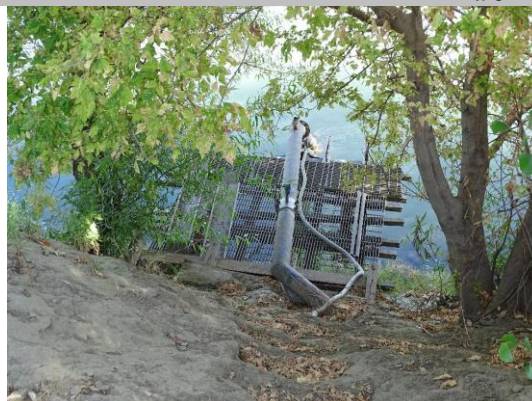
Photo 2 of 3 : UCIP_FA_2019_55915_83201.jpg

Pump platform and pipe with submersible pump on riverbank

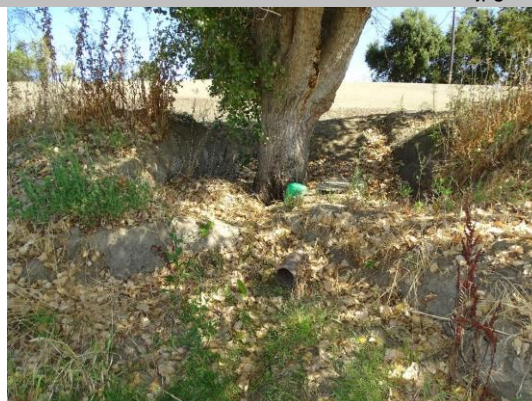
Photo 3 of 3 : UCIP_FA_2019_55915_83202.jpg

6-inch pipe at LS toe

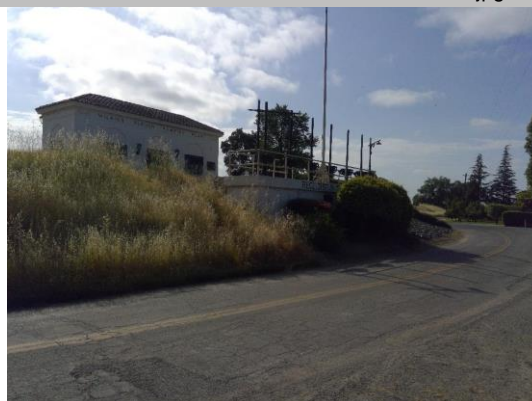
Photo 1 of 3 : UCIP_FA_2019_53940_79167.jpg

Comment Code					
Inspector Comment					
DS_ID:20252 FS_ID:53940 EP_NO: 9354 Repair Type: Non-Urgent Crossing Status: Found UCIP Comments: 05/06/2019 No issues recorded during inspection. (O.Yakimov - DWR UCIP) 09/21/2017 Reclamation District No. 108 diverts irrigation water from the Sacramento River using the Wilkins Slough Pumping Plant. (DWR UCIP - O. Magana) FIELD_STRUCT_DESC: [Wilkins Slough Pumping Plant] 1 of 6: 5-foot by 5-foot reinforced concrete irrigation culvert through the levee, 40 feet below the crown. Control gates on the landside (LS) and waterside (WS) shoulder. Pump on the WS berm. (six 5-foot by 5-foot culverts [HLM 25.88] authorized under Automatic Board Order (ABO) issued as Permit No. 9354, 1974 - Reclamation District No. 108; plant was upgraded with new fish latter in 2005; positive barrier fish screens authorized under Permit No. 16748, 1997 - Reclamation District No. 108 [RD0108]; other related Permit Nos. include 1359 and 1534). [Additional Reference(s): DWR Levee Log, 2006. USACE Sacramento O&M Manual 130, May 1960 (HLM 25.88)]. FS Date: 5/6/2019 9:18:12 AM

View of pumping station on levee crown.

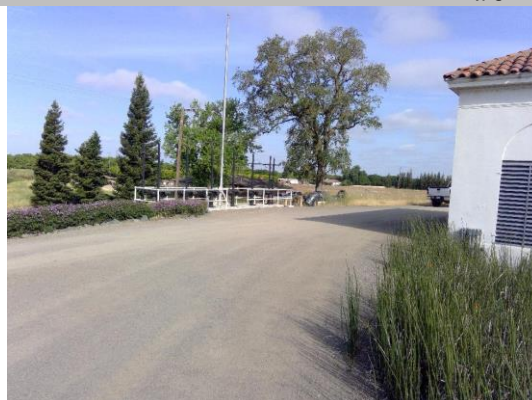
Photo 2 of 3 : UCIP_FA_2019_53940_79166.jpg

View of slide gate on LS shoulder. Six pipes are crossing levee.

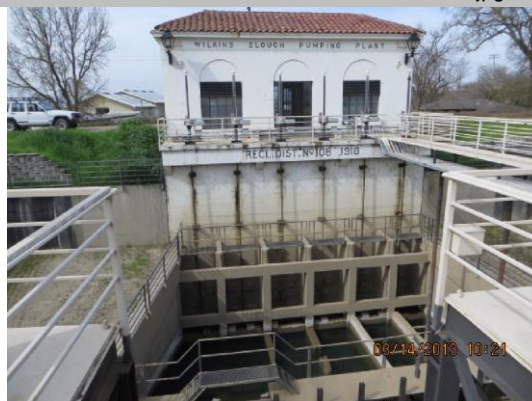
Photo 3 of 3 : UCIP_FA_2019_53940_17501.jpg

Pumphouse on WS shoulder.

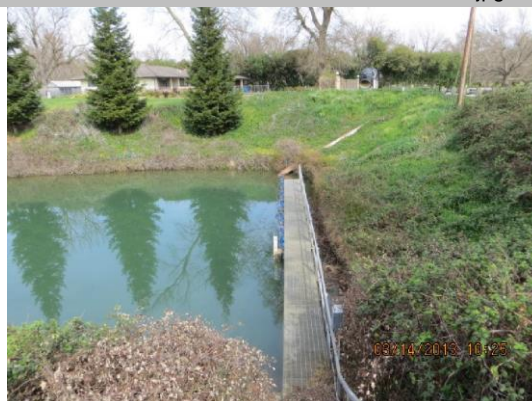
Photo 3 of 3 : UCIP_FA_2019_53968_17502.jpg

Item	DRAFT DWR UCIP Field Study			39.012350 °	39.012350 °	
				-121.827912 °	-121.827912 °	
DWR ID	20371					
Comment Code						
Inspector Comment						
DS_ID:20371 FS_ID:53968 EP_NO: 9354 Repair Type: Non-Urgent Crossing Status: Found UCIP Comments: 09/21/2017 Reclamation District No. 108 diverts irrigation water from the Sacramento River using the Wilkins Slough Pumping Plant. (DWR UCIP - O. Magana) FIELD_STRUCT_DESC: [Wilkins Slough Pumping Plant] 3 of 6: 5-foot by 5-foot reinforced concrete irrigation culvert through the levee, 40 feet below the crown. Control gates on the landside (LS) and waterside (WS) shoulder. Pump on the WS berm. (six 5-foot by 5-foot culverts [HLM 25.88] authorized under Automatic Board Order (ABO) issued as Permit No. 9354, 1974 - Reclamation District No. 108; plant was upgraded with new fish latter in 2005; positive barrier fish screens authorized under Permit No. 16748, 1997 - Reclamation District No. 108 [RD0108]; other related Permit Nos. include 1359 and 1534). [Additional Reference(s): DWR Levee Log, 2006. USACE Sacramento O&M Manual 130, May 1960 (HLM 25.88)]. FS Date: 5/6/2019 1:38:03 PM

Walkway and gates on LS toe.

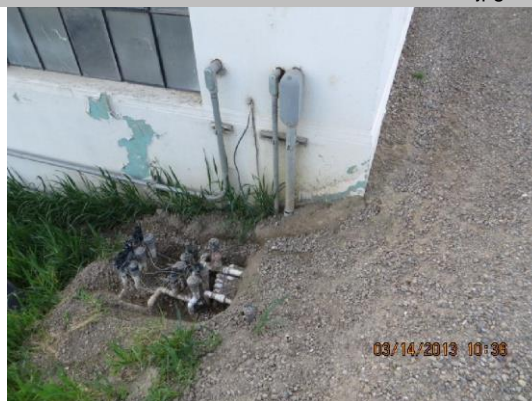
Photo 2 of 2 : UCIP_FA_2019_53972_18721.jpg

LM Start	25.57	Rating **	M	Issue No.	1609 (cont)	
LM End	25.57	Issue Type +	En	Location *		
Category	Supplemental			GPS Latitude/Longitude		
				Start	End	
Item	DRAFT DWR UCIP Field Study			39.012428 °	39.012428 °	
				-121.827907 °	-121.827907 °	
DWR ID	22958					
Comment Code						
Inspector Comment						
DS_ID:22958						
FS_ID:53972						
EP_NO: N/A						
Repair Type: Non-Urgent						
Crossing Status: Found						
UCIP Comments: 05/06/2019 Permit is not available for this crossing.						
(O.Yakimov - DWR UCIP)						
FIELD_STRUCT_DESC: 1.5-inch polyvinyl chloride irrigation line						
through the levee, 2 feet below the crown. Distribution manifold at the						
corner of building on waterside (WS) shoulder.						
FS Date: 5/6/2019 2:20:57 PM

Waterline and distribution manifold at WS shoulder/corner of pumphouse.

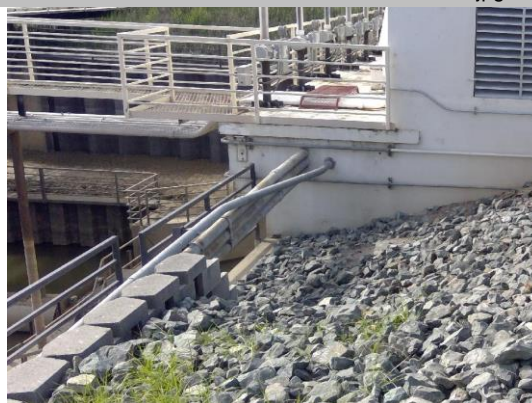
Photo 1 of 3 : UCIP_FA_2019_53973_79179.jpg

LM Start	25.58	Rating **	M	Issue No.	1610
LM End	25.58	Issue Type +	En	Location *	
Category	Supplemental			GPS Latitude/Longitude	
				Start	End
Item	DRAFT DWR UCIP Field Study			39.012562 °	39.012562 °
				-121.827853 °	-121.827853 °
DWR ID	22960				
Comment Code					
Inspector Comment					
DS_ID:22960					
FS_ID:53973					
EP_NO: N/A					
Repair Type: Non-Urgent					
Crossing Status: Found					
UCIP Comments: 05/06/2019 No issues recorded during inspection.					
(O.Yakimov - DWR UCIP)					
FIELD_STRUCT_DESC: 1 of 4: 4-inch galvanized iron electrical conduit					
through the levee, 3 feet below the crown. Pipe runs from an electric					
vault on the landside (LS) shoulder to a building on the waterside (WS)					
shoulder.					
FS Date: 5/6/2019 2:44:19 PM

Closer view of conduits coming out of building

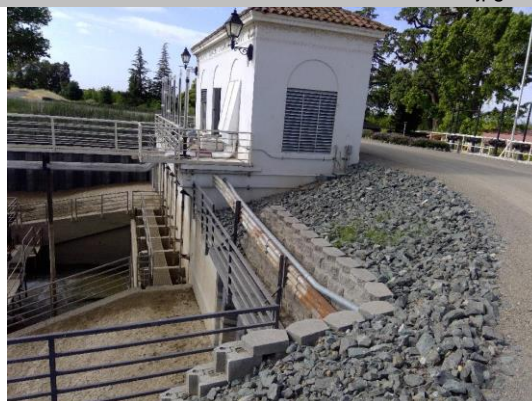
Photo 2 of 3 : UCIP_FA_2019_53973_79180.jpg

Four conduits crossing the levee. View of WS slope

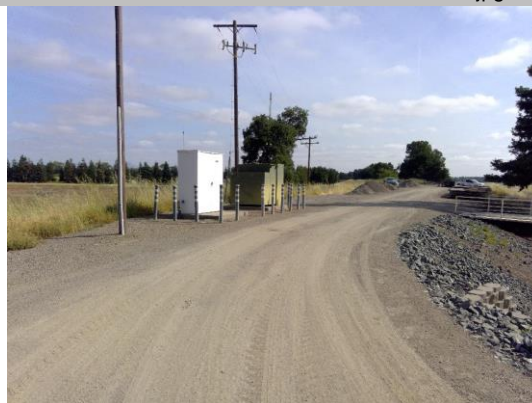
Photo 3 of 3 : UCIP_FA_2019_53973_79182.jpg

Top of Levee with electrical vaults on LS shoulder

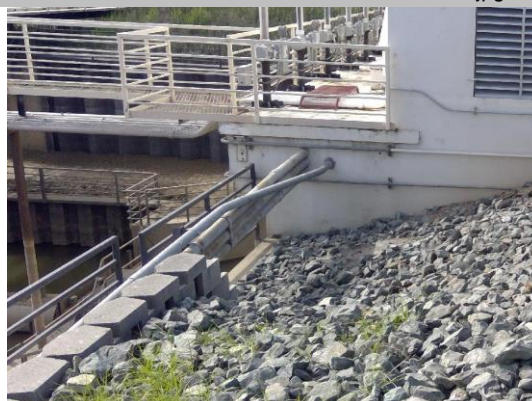
Photo 1 of 3 : UCIP_FA_2019_53974_79183.jpg

LM Start	25.58	Rating **	M	Issue No.	1611
LM End	25.58	Issue Type +	En	Location *	
Category	Supplemental			GPS Latitude/Longitude	
				Start	End
Item	DRAFT DWR UCIP Field Study			39.012562 °	39.012562 °
				-121.827853 °	-121.827853 °
DWR ID	22961				
Comment Code					
Inspector Comment					
DS_ID:22961					
FS_ID:53974					
EP_NO: N/A					
Repair Type: Non-Urgent					
Crossing Status: Found					
UCIP Comments: 05/06/2019 No issues recorded during inspection.					
(O.Yakimov - DWR UCIP)					
FIELD_STRUCT_DESC: 2 of 4: 4-inch galvanized iron electrical conduit					
through the levee, 3.4 feet below the crown. Pipe runs from an electric					
vault on the landside (LS) shoulder to a building on the waterside (WS)					
shoulder.					
FS Date: 5/6/2019 2:56:10 PM

Closer view of conduits coming out of building

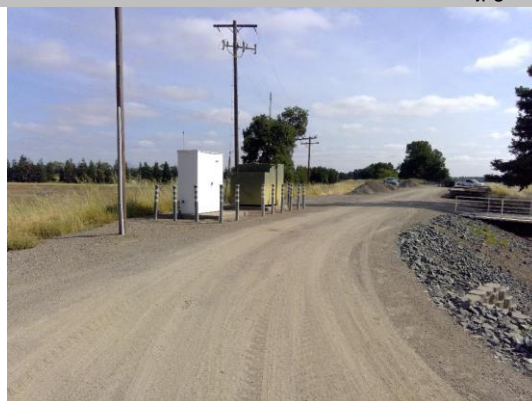
Photo 3 of 3 : UCIP_FA_2019_53974_79186.jpg

LM Start	25.58	Rating **	M	Issue No.	1611 (cont)	
LM End	25.58	Issue Type +	En	Location *		
Category	Supplemental			GPS Latitude/Longitude		
				Start	End	
Item	DRAFT DWR UCIP Field Study			39.012562 °	39.012562 °	
				-121.827853 °	-121.827853 °	
DWR ID	22961					
Comment Code						
Inspector Comment						
DS_ID:22961 FS_ID:53974 EP_NO: N/A Repair Type: Non-Urgent Crossing Status: Found UCIP Comments: 05/06/2019 No issues recorded during inspection. (O.Yakimov - DWR UCIP) FIELD_STRUCT_DESC: 2 of 4: 4-inch galvanized iron electrical conduit through the levee, 3.4 feet below the crown. Pipe runs from an electric vault on the landside (LS) shoulder to a building on the waterside (WS) shoulder. FS Date: 5/6/2019 2:56:10 PM

Top of Levee with electrical vaults on LS shoulder

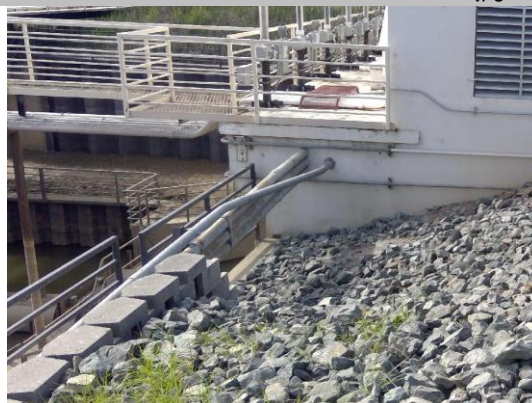
Photo 1 of 3 : UCIP_FA_2019_53975_79187.jpg

LM Start	25.58	Rating **	M	Issue No.	1612
LM End	25.58	Issue Type +	En	Location *	
Category	Supplemental			GPS Latitude/Longitude	
				Start	End
Item	DRAFT DWR UCIP Field Study			39.012562 °	39.012562 °
				-121.827853 °	-121.827853 °
DWR ID	22962				
Comment Code					
Inspector Comment					
DS_ID:22962					
FS_ID:53975					
EP_NO: N/A					
Repair Type: Non-Urgent					
Crossing Status: Found					
UCIP Comments: 05/06/2019 No issues recorded during inspection.					
(O.Yakimov - DWR UCIP)					
FIELD_STRUCT_DESC: 3 of 4: 4-inch galvanized iron electrical conduit					
through the levee, 3.8 feet below the crown. Pipe runs from an electric					
vault on the landside (LS) shoulder to a building on the waterside (WS)					
shoulder.					
FS Date: 5/6/2019 2:57:32 PM

Closer view of conduits coming out of building

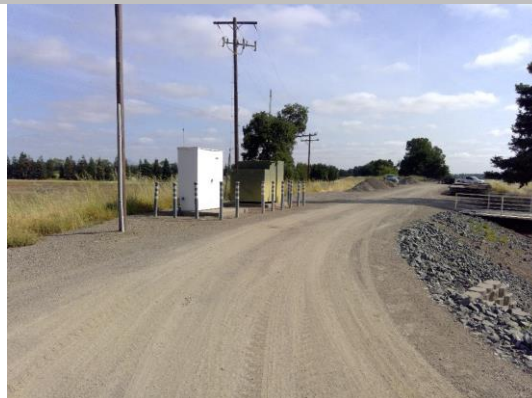
Photo 3 of 3 : UCIP_FA_2019_53976_79194.jpg

LM Start	25.58	Rating **	M	Issue No.	1613 (cont)	
LM End	25.58	Issue Type +	En	Location *		
Category	Supplemental			GPS Latitude/Longitude		
				Start	End	
Item	DRAFT DWR UCIP Field Study			39.012562 °	39.012562 °	
				-121.827853 °	-121.827853 °	
DWR ID	22963					
Comment Code						
Inspector Comment						
DS_ID:22963 FS_ID:53976 EP_NO: N/A Repair Type: Non-Urgent Crossing Status: Found UCIP Comments: 05/06/2019 No issues recorded during inspection. (O.Yakimov - DWR UCIP) FIELD_STRUCT_DESC: 4 of 4: 4-inch galvanized iron electrical conduit through the levee, 4.2 feet below the crown. Pipe runs from an electric vault on the landside (LS) shoulder to a building on the waterside (WS) shoulder. FS Date: 5/6/2019 2:58:34 PM

Top of Levee with electrical vaults on LS shoulder

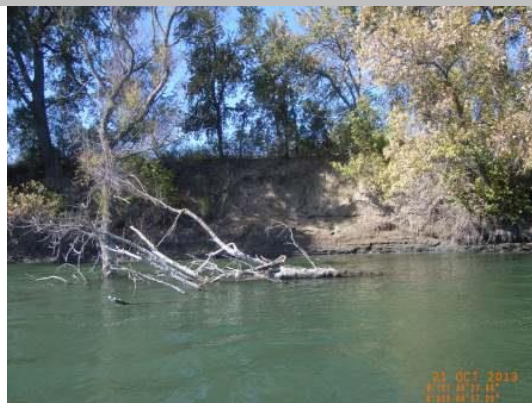
Photo 1 of 1 : FA_2019_NA0016_435_88_20190829_00026.jpg

LM Start	25.75	Rating **	A/W	Issue No.	88
LM End	25.91	Issue Type +	Ma	Location *	WS
Category	Supplemental			GPS Latitude/Longitude	
				Start	End
Item	2017 USACE Erosion Survey			39.014499 °	39.016401 °
				-121.825880 °	-121.824230 °
DWR ID	DWR_NA0016_01_f_2018_88				
Comment Code					
Inspector Comment					
2017 Site ID: SAC 118.0 R					
Status: Eroding					
2017 Field Notes: No observed change.					
Site History: 2008 - Whole bank is eroding, nearly vertical slope with cohesive toe. Bed is very deep along the toe (greater than 30 ft deep at 20 ft from the shore). 2011 - Some new minor erosion. 2016 - Minor new erosion.

USACE 2013 Photo #1

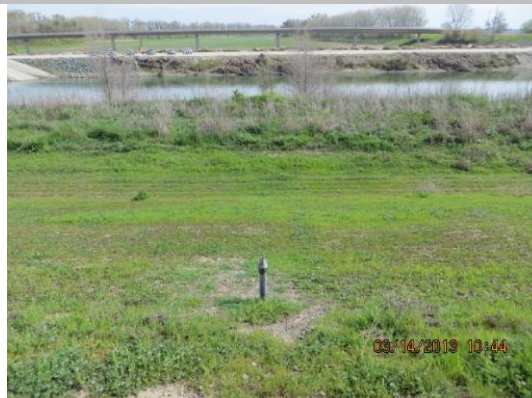
Photo 2 of 3 : UCIP_FA_2019_53977_17531.jpg

LM Start	26.46	Rating **	M	Issue No.	1614 (cont)
LM End	26.46	Issue Type +	En	Location *

Air release valve on WS shoulder.

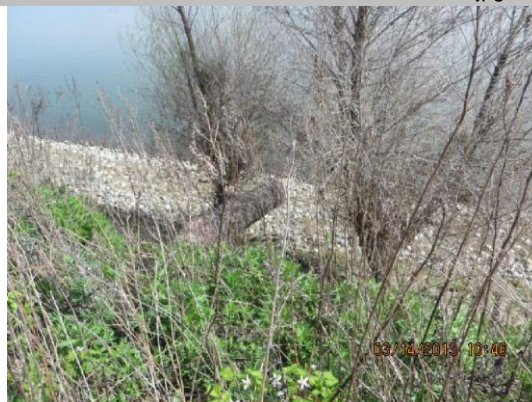
Photo 3 of 3 : UCIP_FA_2019_53977_17534.jpg

Pipe at Rivers edge.

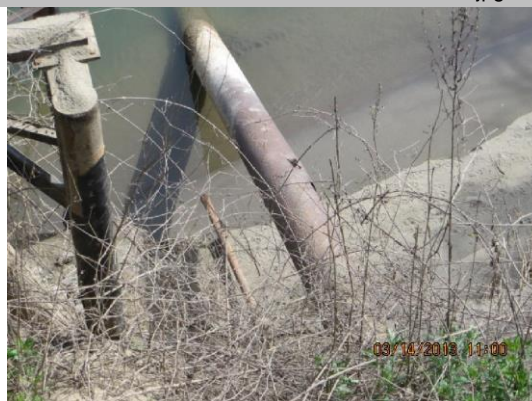
Photo 1 of 3 : UCIP_FA_2019_56073_17538.jpg

LM Start	26.58	Rating **	M	Issue No.	1615 (cont)
LM End	26.58	Issue Type +	En	Location *

Pipe visible at waters edge.

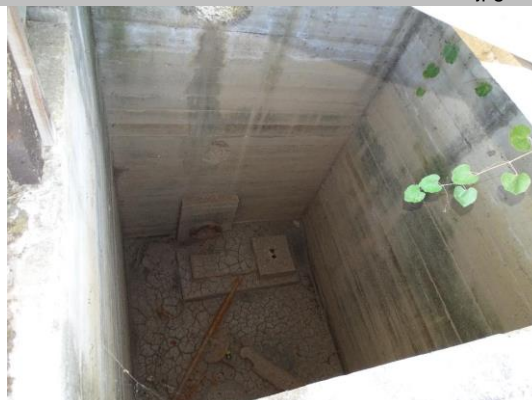
Photo 2 of 3 : UCIP_FA_2019_56073_83207.jpg

Open pipe in concrete sump coming from riverbank

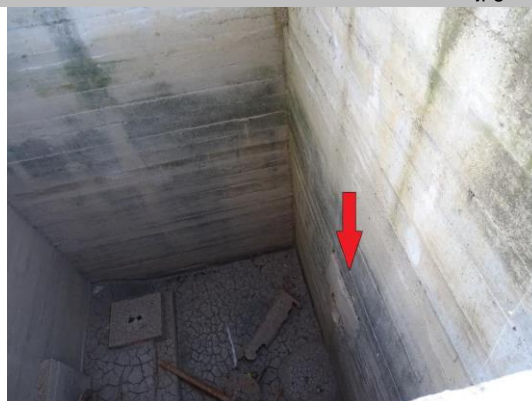
Photo 3 of 3 : UCIP_FA_2019_56073_83209.jpg

Item	DRAFT DWR UCIP Field Study			39.025623 °	39.025623 °	
				-121.823436 °	-121.823436 °	
DWR ID	20254					
Comment Code						
Inspector Comment						
DS_ID:20254 FS_ID:56073 EP_NO: 9371 Repair Type: Non-Urgent Crossing Status: Found UCIP Comments: 10/01/2019 Pipe is not found on LS. Open pipe end is visible in concrete sump at riverbank. Pipe that was coming out from sump towards levee has been removed and its hole in sump was immured. (O.Yakimov - DWR UCIP) FIELD_STRUCT_DESC: *ABANDONED* 1 of 2: 14-inch steel irrigation pipe through the levee, 4.5 feet below the crown. Slant pump on steel structure on the waterside (WS) bank. Screw gate at pump to divert water into concrete sump on the WS berm. Concrete tank on the landside (LS) across the county road. Steel plate bolted on the WS end. (two 14-inch pipes, at different depths, authorized under Automatic Board Order (ABO) issued as Permit No. 9371, 1974 - Fred, Lloyd, and Beverly Durst; 14-inch pipe grouted in place in 2000 under PN 9371 as per permit notes). [Additional Reference(s): DWR Levee Log, 2006. USACE Sacramento O&M Manual 131, May 1960 (HLM 26.92), one 14-inch pipe referenced]. FS Date: 10/1/2019 2:58:00 PM

Immured hole at bottom part of sump on the wall looking towards levee

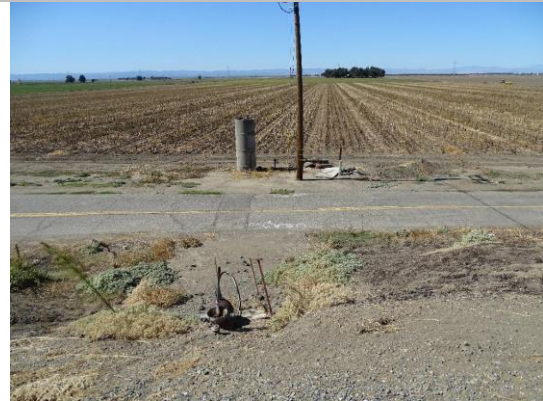
Photo 1 of 3 : UCIP_FA_2019_56074_83212.jpg

LM Start	26.58	Rating **	M	Issue No.	1616 (cont)
LM End	26.58	Issue Type +	En	Location *

View of LS looking from levee crown

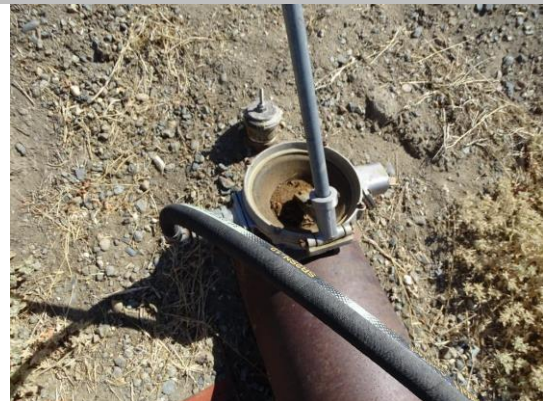
Photo 2 of 3 : UCIP_FA_2019_56074_83211.jpg

Hand pump on LS shoulder
